Extent of Ings Beck Quarry at NGr. 380117 445035

A public footpath walk-over survey by Peter and Brian

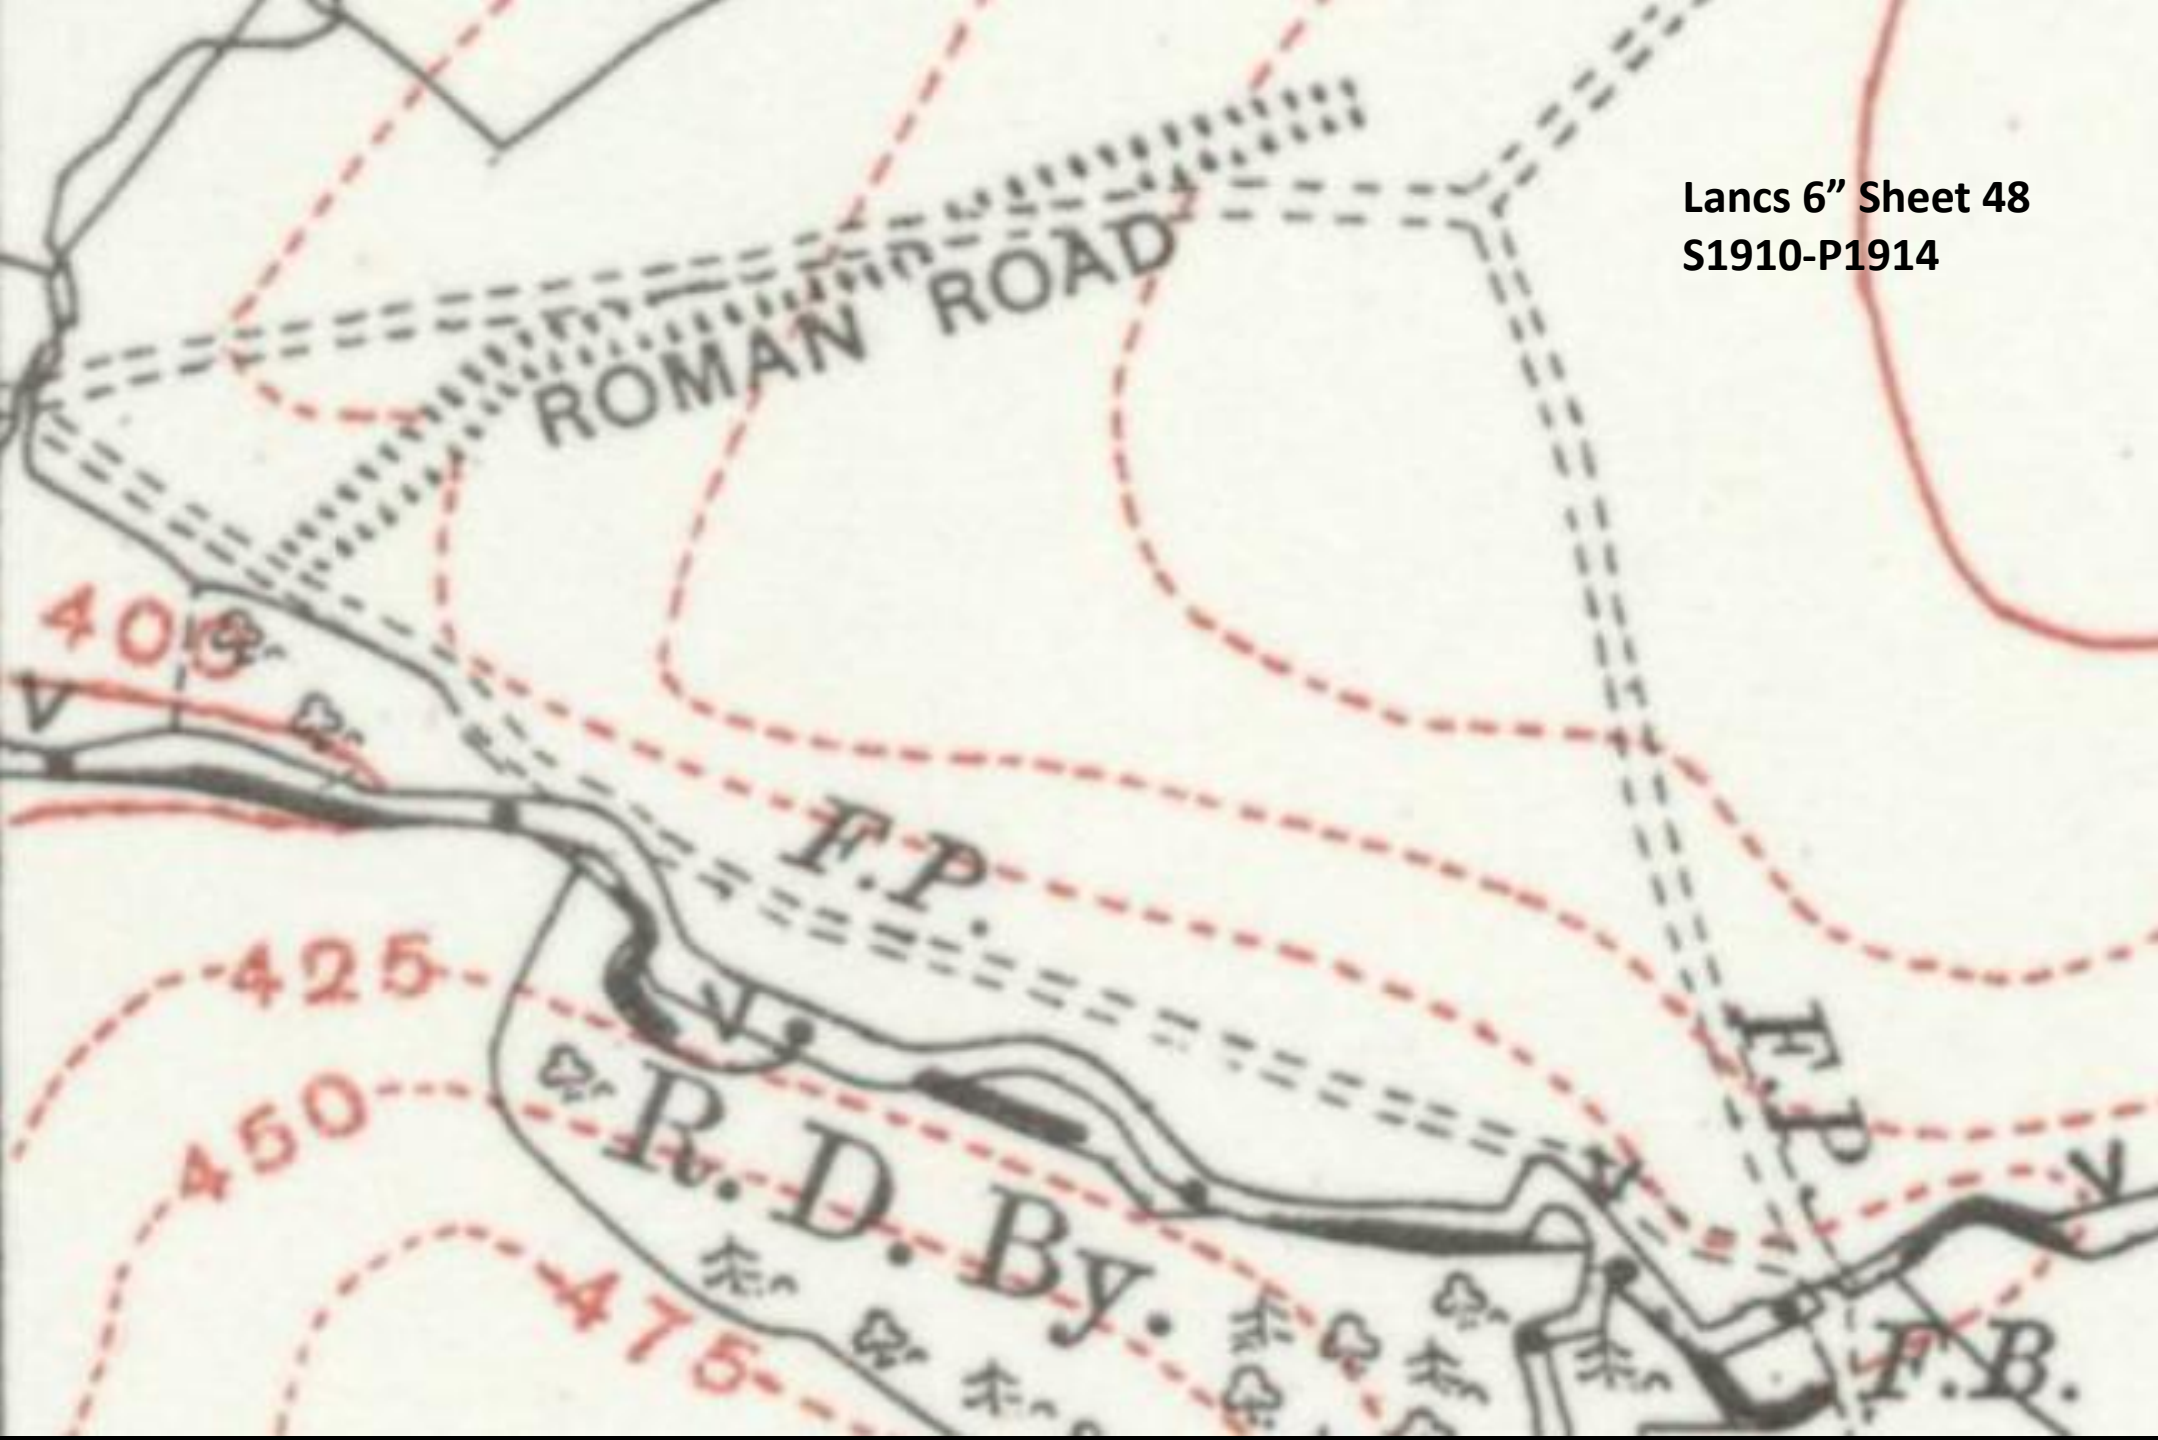
**Does the quarry area  
show 2 classic  
landslip scars or old  
working areas to east  
and north-west.**

**Q = quarry**

**QW = quarry waste?**

**Richard Higgins thinks  
the marked area is of  
a different material  
to the rest of the field.  
It is poor quality pasture  
and likely to be dumped  
material, possibly quarry  
overburden.**

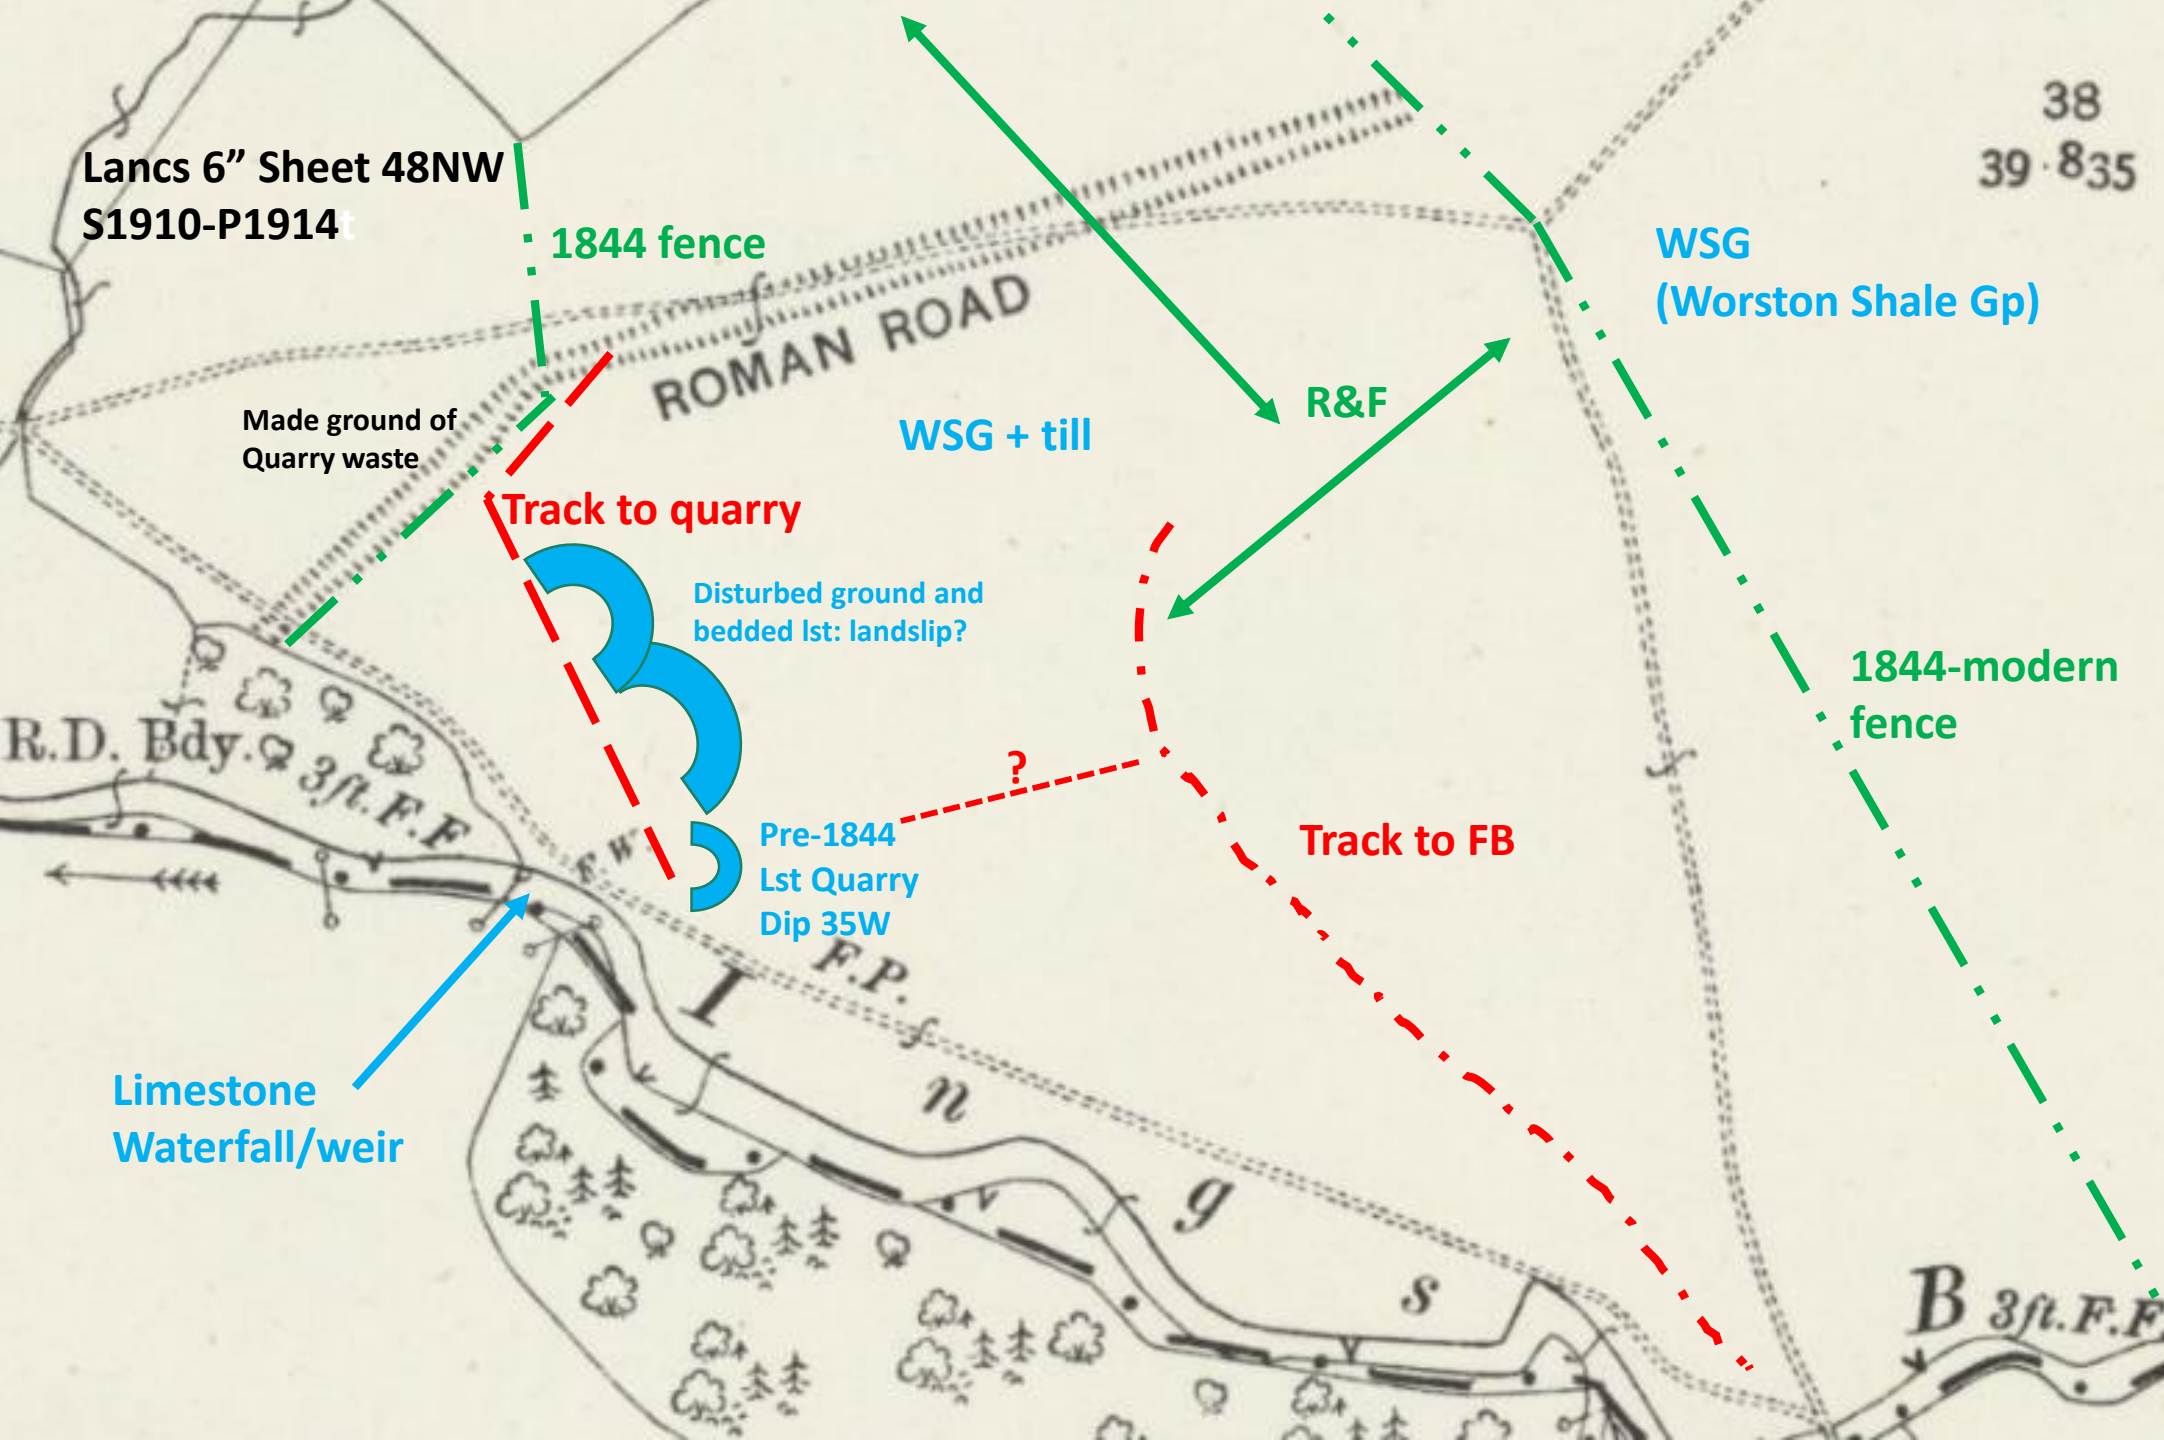
Lancs 6" Sheet 48NW  
S1910-P1914†

1844 fence

Made ground of  
Quarry waste

ROMAN ROAD

WSG + till

WSG  
(Worston Shale Gp)

Disturbed ground and  
bedded lst: landslip?

Pre-1844  
Lst Quarry  
Dip 35W

Limestone  
Waterfall/weir
